# **Conservation Management Plan - draft**

**Seatoun Wharf, Seatoun, Wellington**

**May 2021**

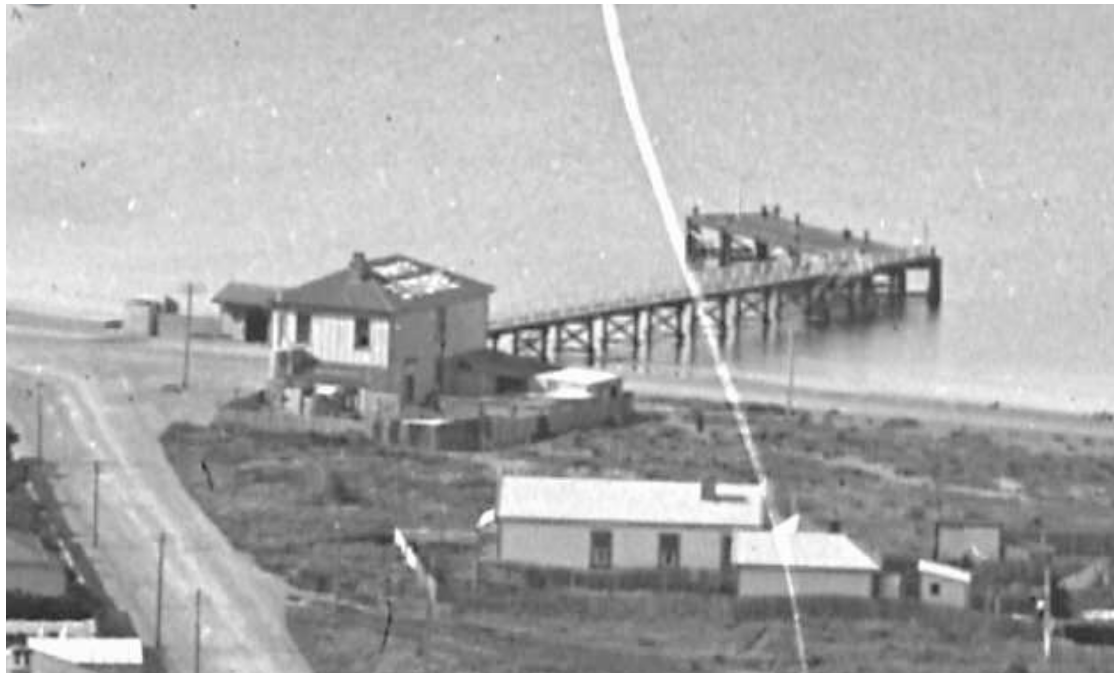
Figure 14 Seatoun wharf 1916, showing cross bracing of the approach wharf, the tea rooms, changing shed and shelter, ATL 1/4-018521-G

Figures 14 and 15 show a number of light fittings which were not original and are no longer on the wharf. Some copper sheathing remains on the perimeter joists of the main wharf and some piles.

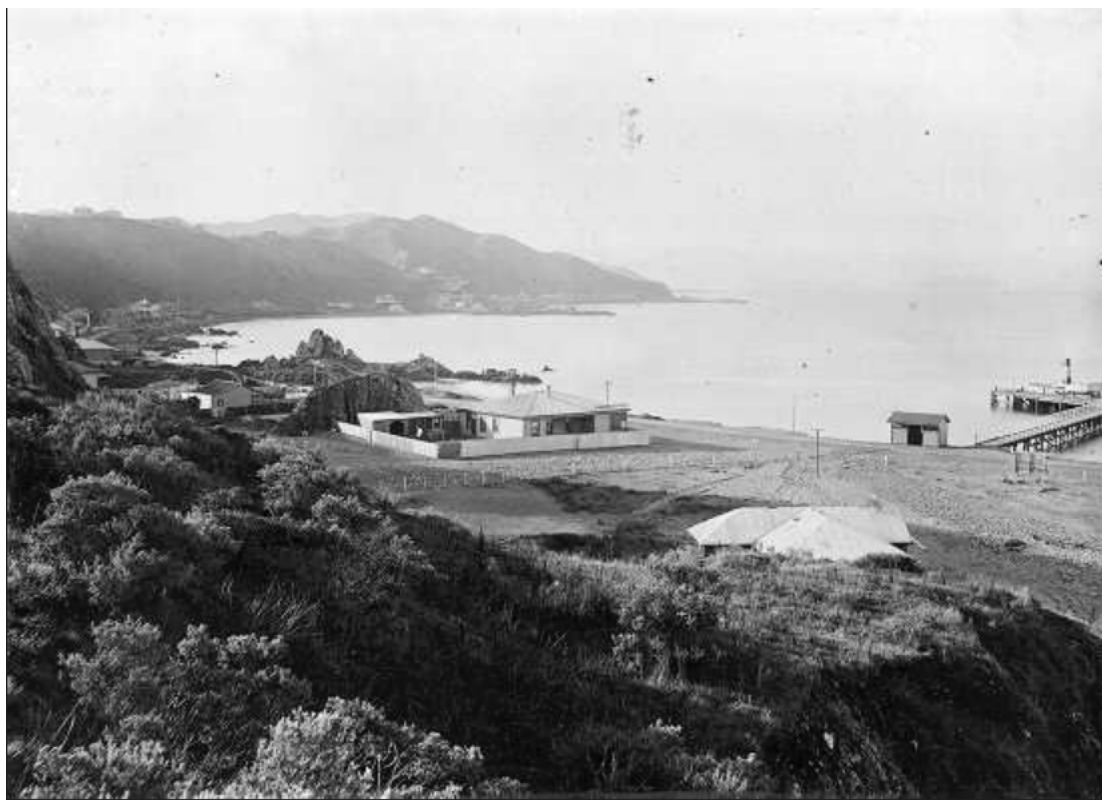
Figure 15 Wharf showing newly built passenger shelter, 1904, PAColl-7489-95

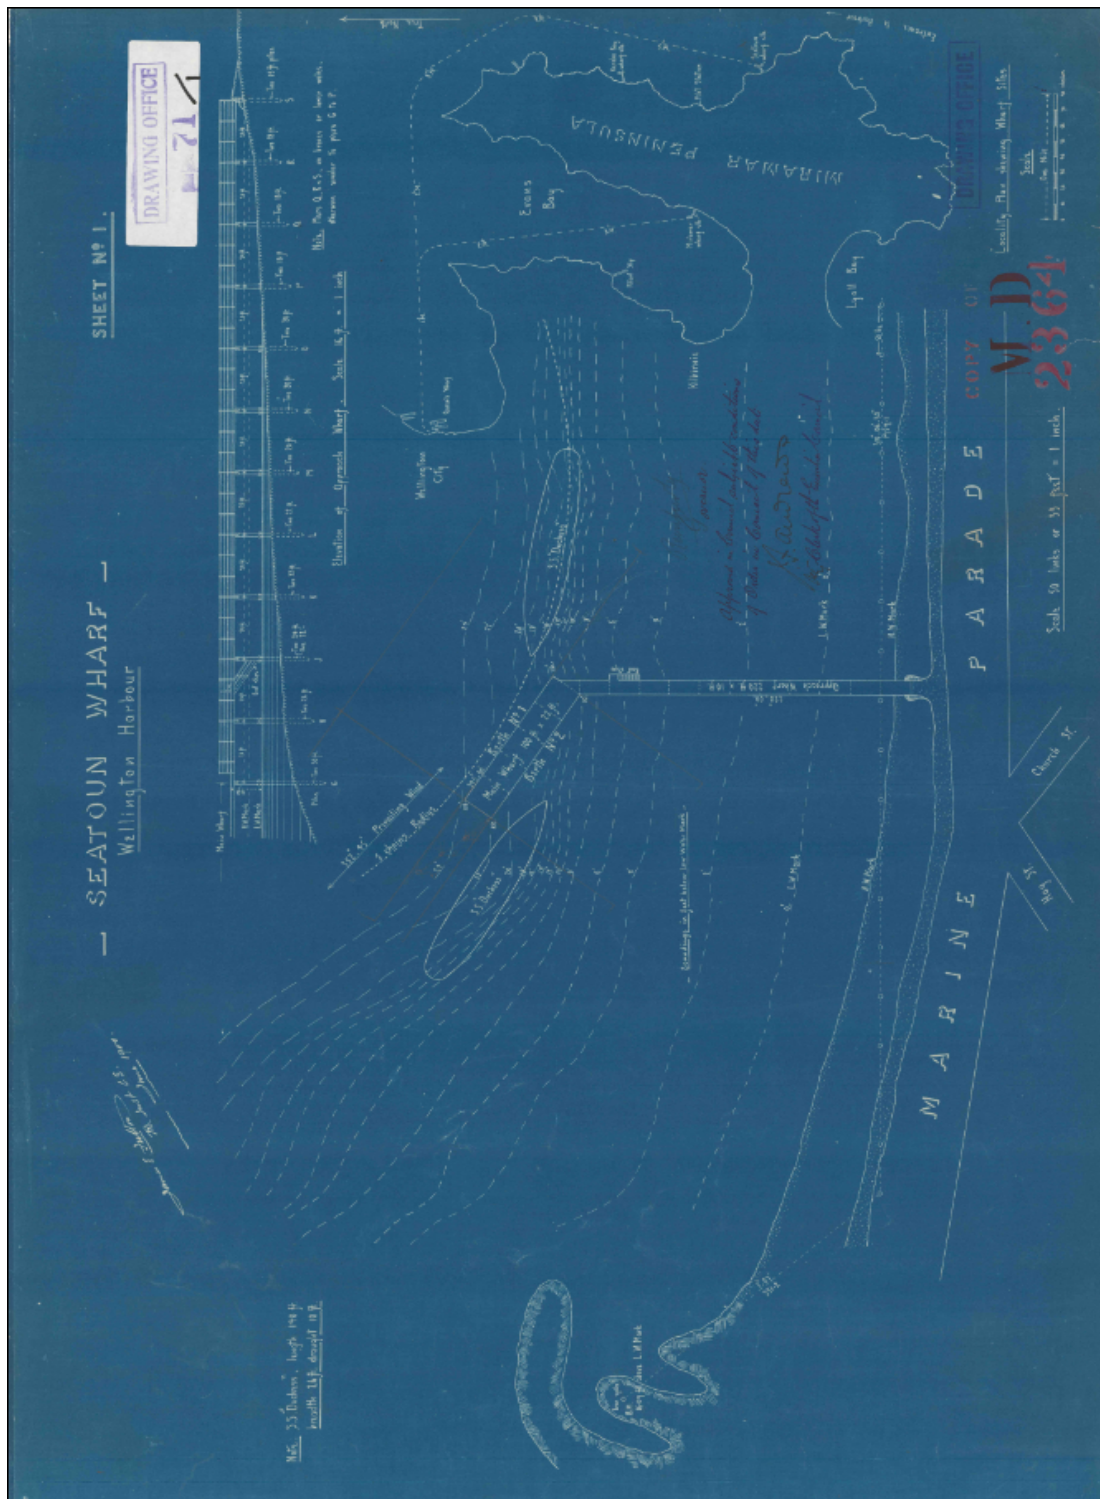
Figure 21 Plans for Seatoun wharf, WCA, AC046-71
